# RV Inspection Report

**Inspection Date:** 6/15/2021

**RV Model: 2018 KZ CONNECT C281BH**

**Mission RV Services**

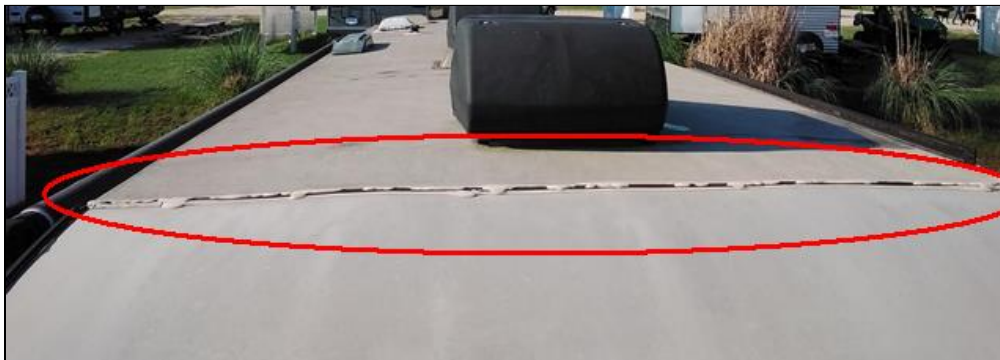
Front Cap to Roof Sealant

The owner would not allow the inspector on the roof, therefore most of the sealant and roof areas could not be inspected correctly. Based on the inspection performed from the ladder, the inspector viewed areas of concern with the sealant between the front cap and the roof. It is recommended that this be repaired by a qualified RV technician as this could become a source of future water intrusion.

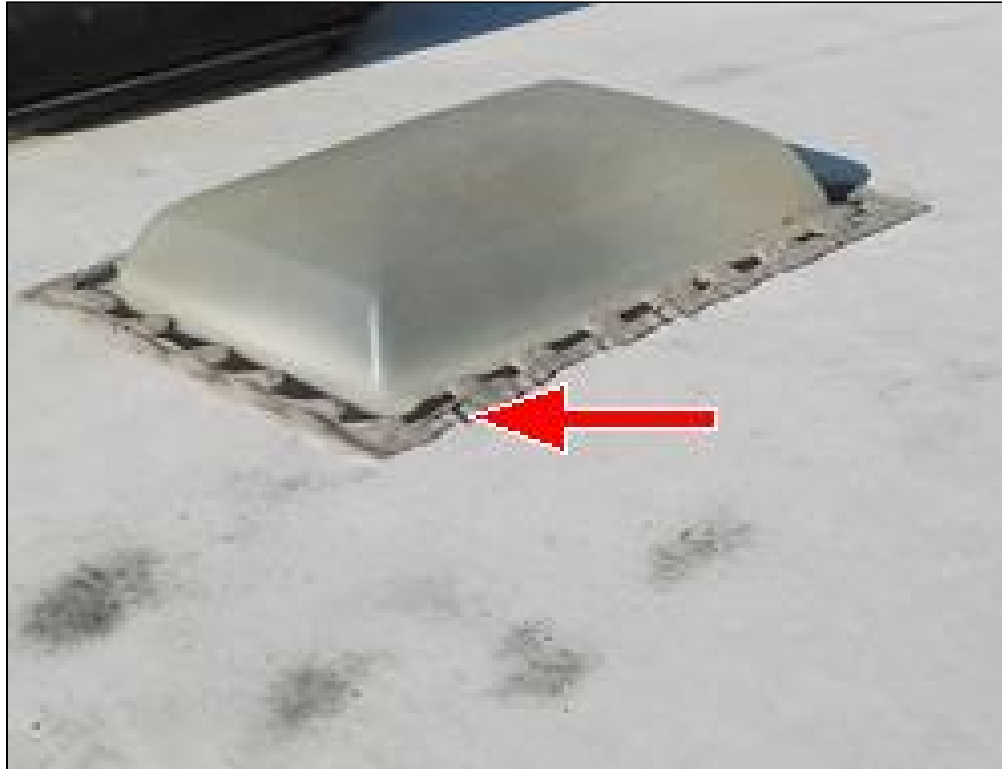
Kitchen Skylight center of trailer

(1) The inspector observed that the Kitchen/Living room skylight at the center of the trailer, has UV damage and has sealant cracking on the side of the skylight, facing the front. It is recommended that the sealant be repaired by a qualified RV technician to prevent future water intrusion.

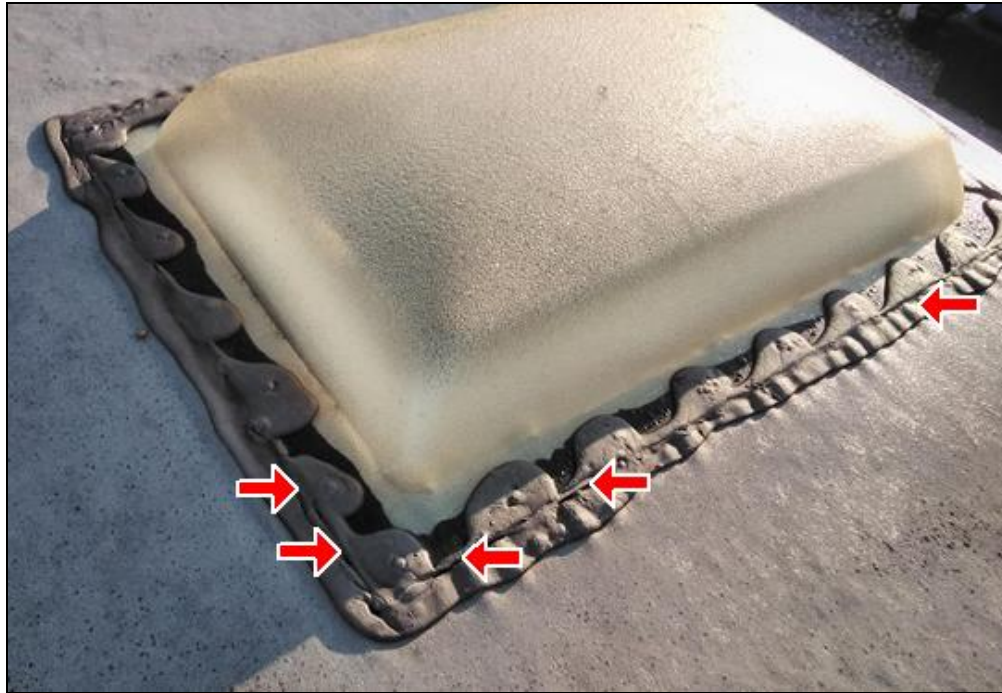
Rear of trailer Bathroom Skylight

(2) The inspector observed that the bathroom skylight at the curbside rear of the trailer, is yellowing from UV exposure, and has sealant cracking all around it. It is recommended that the sealant be repaired by a qualified RV technician to prevent future water intrusion.

**\$** (2) The inspector observed that the bathroom skylight at the curbside rear of the trailer, is yellowing from UV exposure, and has sealant cracking all around it. It is recommended that the sealant be repaired by a qualified RV technician to prevent future water intrusion.

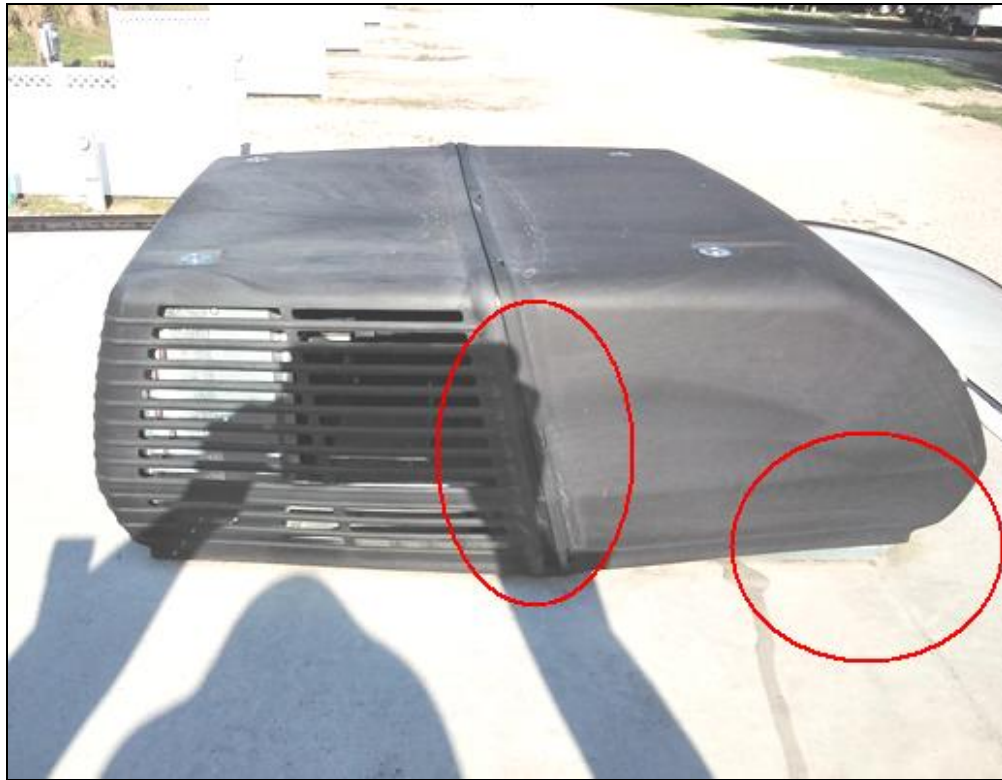
Front Air Conditioner

The inspector observed that the two piece shroud cover on the front air conditioner (A/C Unit #1), has signs of UV damage and is coming apart. The shroud is lifting off of the frame of the unit and could come off during travel. It is recommend that the issue with the shroud coming off be repaired by a qualified RV technician before moving the trailer.

**+** The inspector observed that the two piece shroud cover on the front air conditioner (A/C Unit #1), has signs of UV damage and is coming apart. The shroud is lifting off of the frame of the unit and could come off during travel. It is recommend that the issue with the shroud coming off be repaired by a qualified RV technician before moving the trailer.

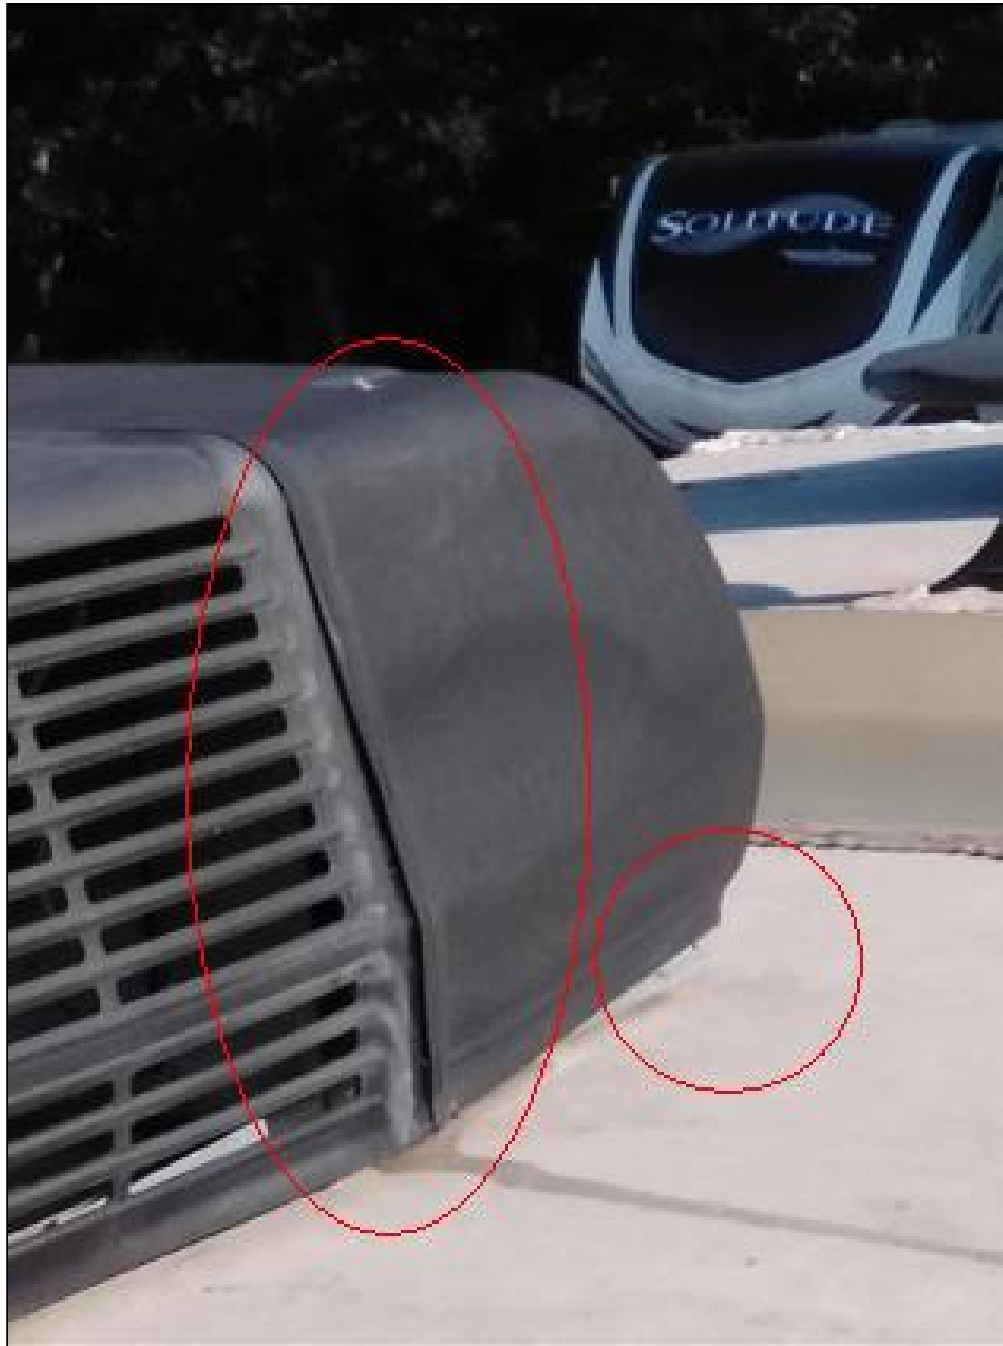
Rear air conditioner shroud

The inspector observed that the two piece shroud cover on the rear air conditioner (A/C Unit #2), has signs of UV damage and it is coming apart. Shroud is lifting off of the frame of the unit, and could come off during travel. It is recommend that the issue with the shroud coming off be repaired by a qualified RV technician before moving the trailer.

**+** The inspector observed that the two piece shroud cover on the rear air conditioner (A/C Unit #2), has signs of UV damage and it is coming apart. Shroud is lifting off of the frame of the unit, and could come off during travel. It is recommend that the issue with the shroud coming off be repaired by a qualified RV technician before moving the trailer.

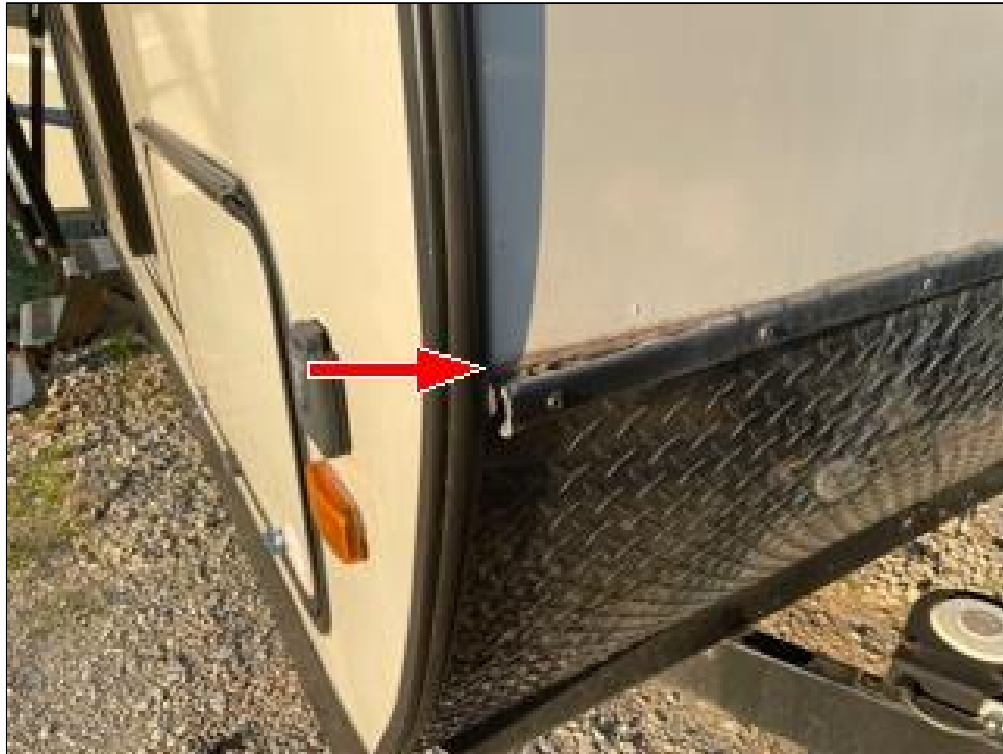
Trim coming off of trailer

The inspector observed that the front cap trim on the curbside, just above the corrugated metal, is coming loose from the trailer. It is recommend this be repaired by a qualified RV technician as this could become a source of future water intrusion.

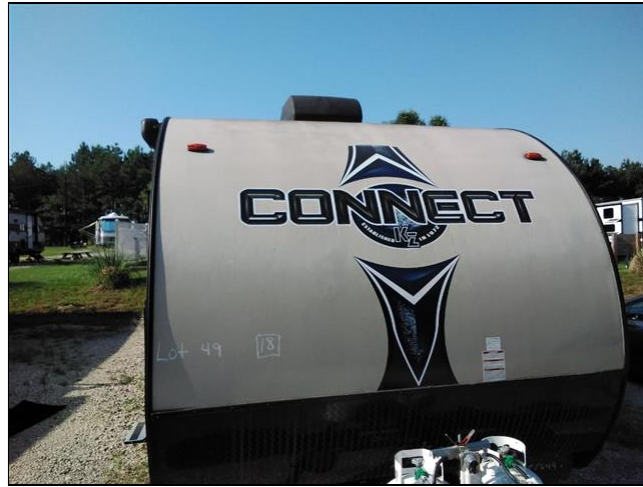
Frontcap wall

The inspector observed signs of fading and discoloration on the frontcap and decals.

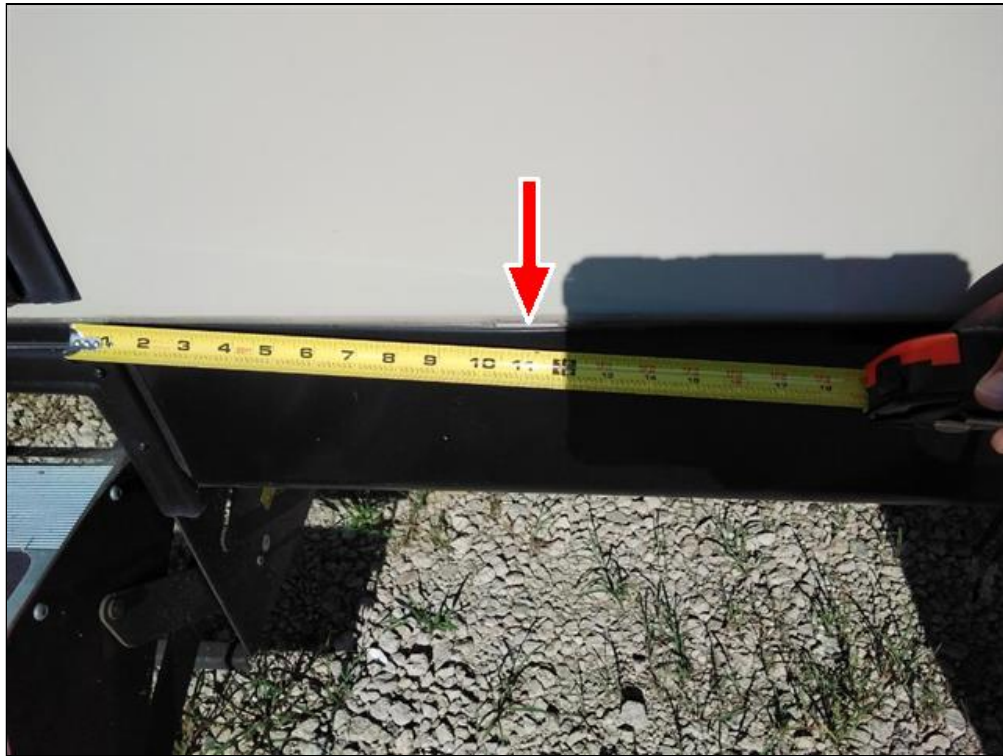
Sealant Issue curbside front

(1) The inspector observed sealant damage on the curbside sidewall, 10 inches to the right of front door. It is recommend this be repaired by a qualified RV technician to avoid future water intrusion.
-

**\$** (1) The inspector observed sealant damage on the curbside sidewall, 10 inches to the right of front door. It is recommend this be repaired by a qualified RV technician to avoid future water intrusion.

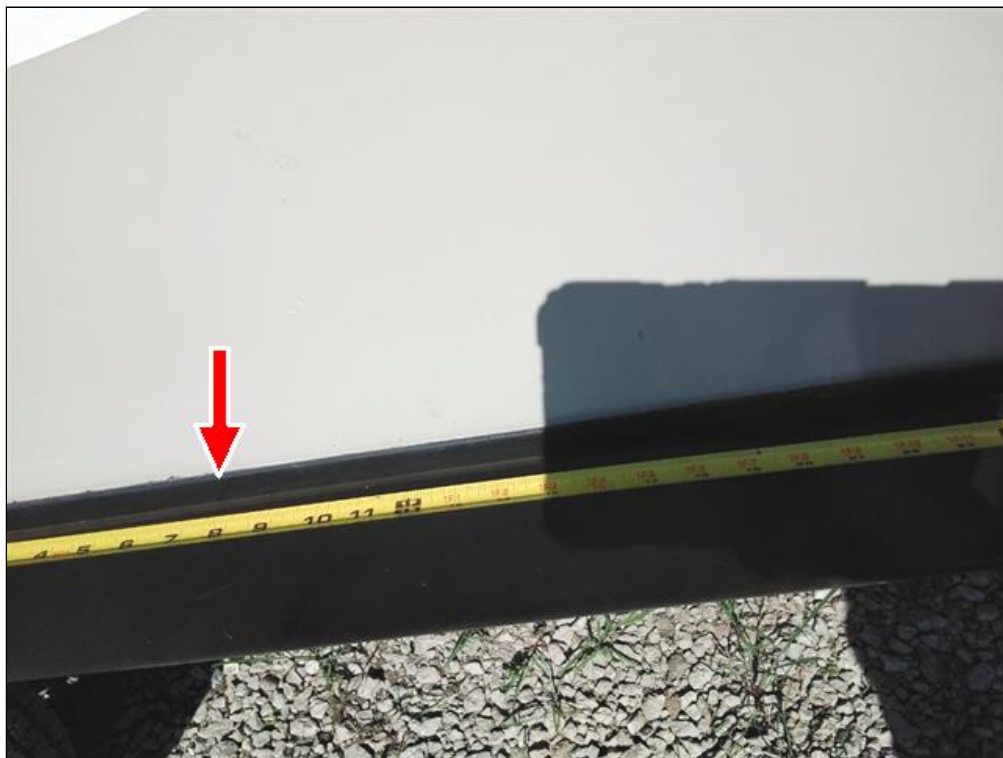
curbside behind door 1

(2) The inspector observed sealant damage on the curbside sidewall, 12 inches to the left of the rear door. It is recommend this be repaired by qualified RV technician to avoid future water damage.

**\$** (2) The inspector observed sealant damage on the curbside sidewall, 12 inches to the left of the rear door. It is recommend this be repaired by qualified RV technician to avoid future water damage.

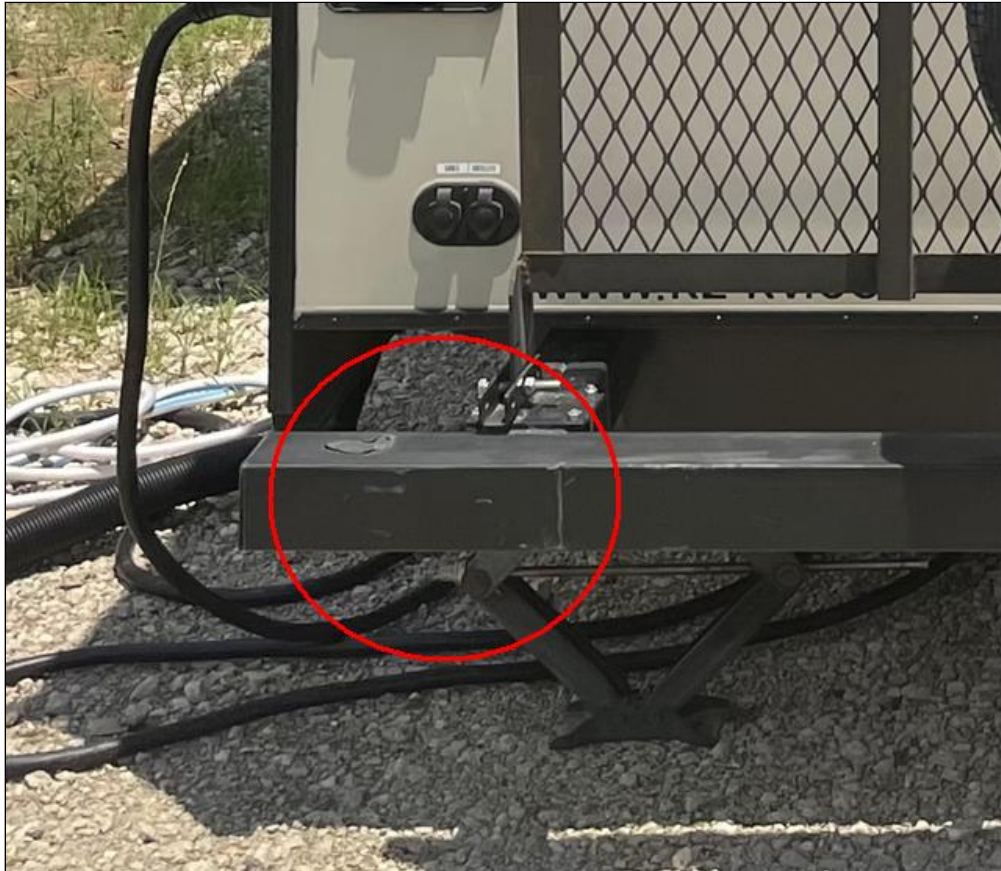
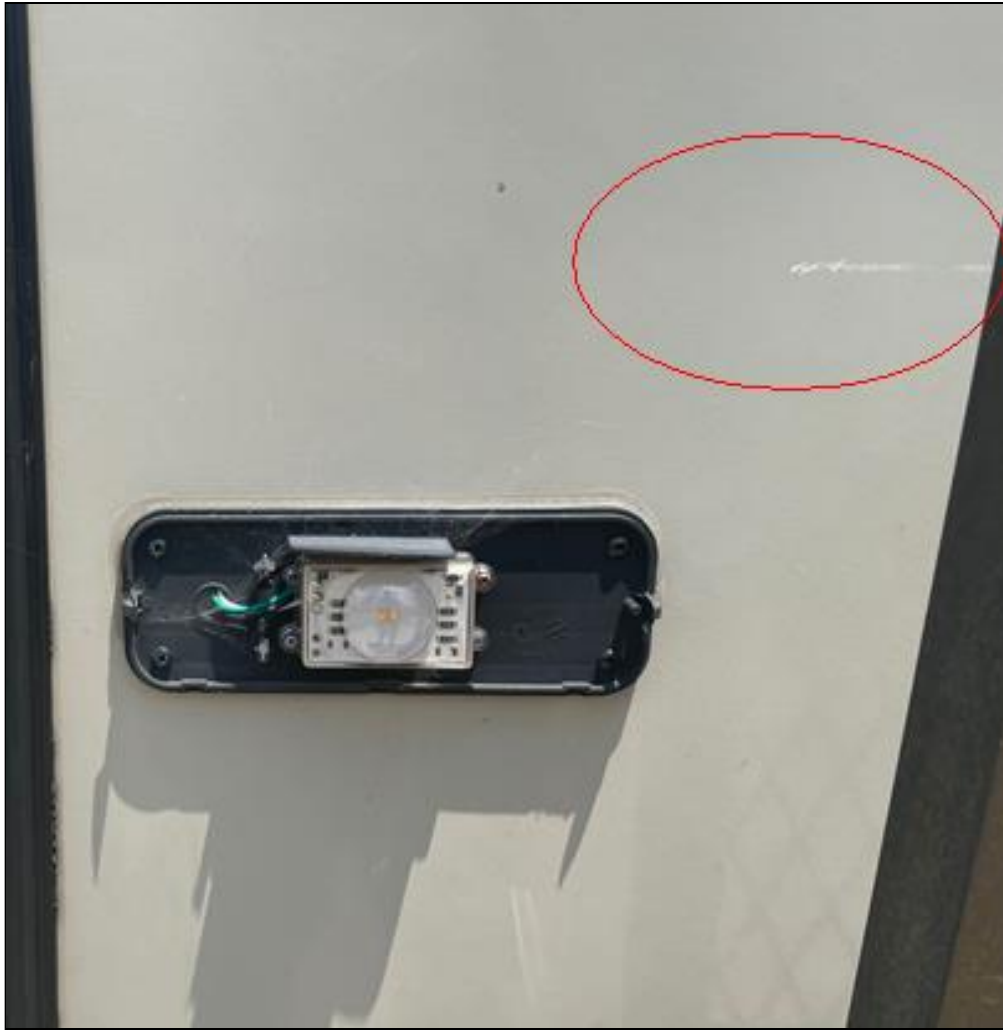
(1) The inspector observed spots of rust and paint scratches on the streetside of the rear bumper.

Rear Cap Bumper

Scratch right of streetside taillight

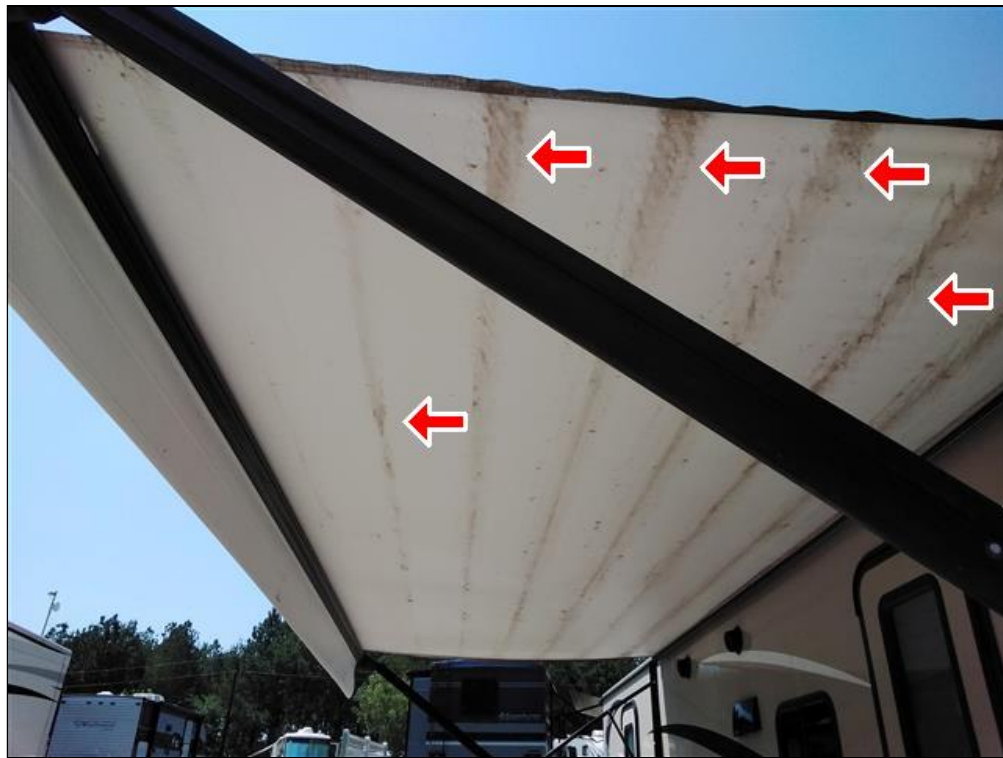
Awning discoloration

The inspector observed discoloration of the awning in sections, covering the length of the underside of the awning in stripes.

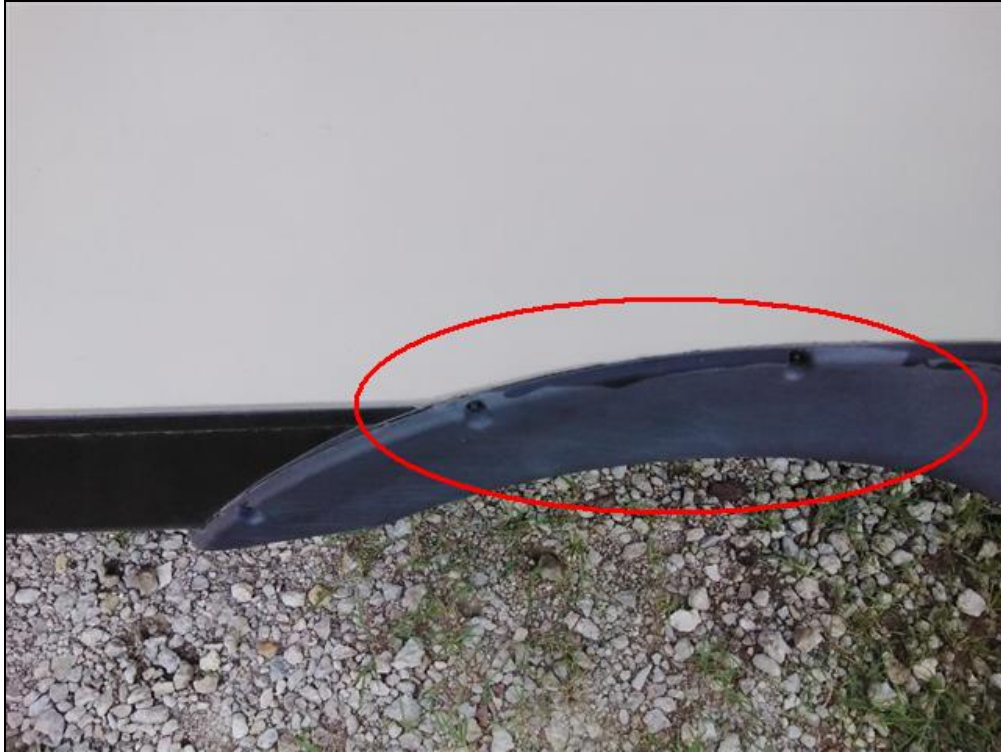
Streetside T molding above Streetside front tire

(1) The inspector observed an area where there is a gap, in the sealant for the T-Molding, on the slideout tire trim. It is recommend this be repaired by a qualified RV technician to avoid future water intrusion.

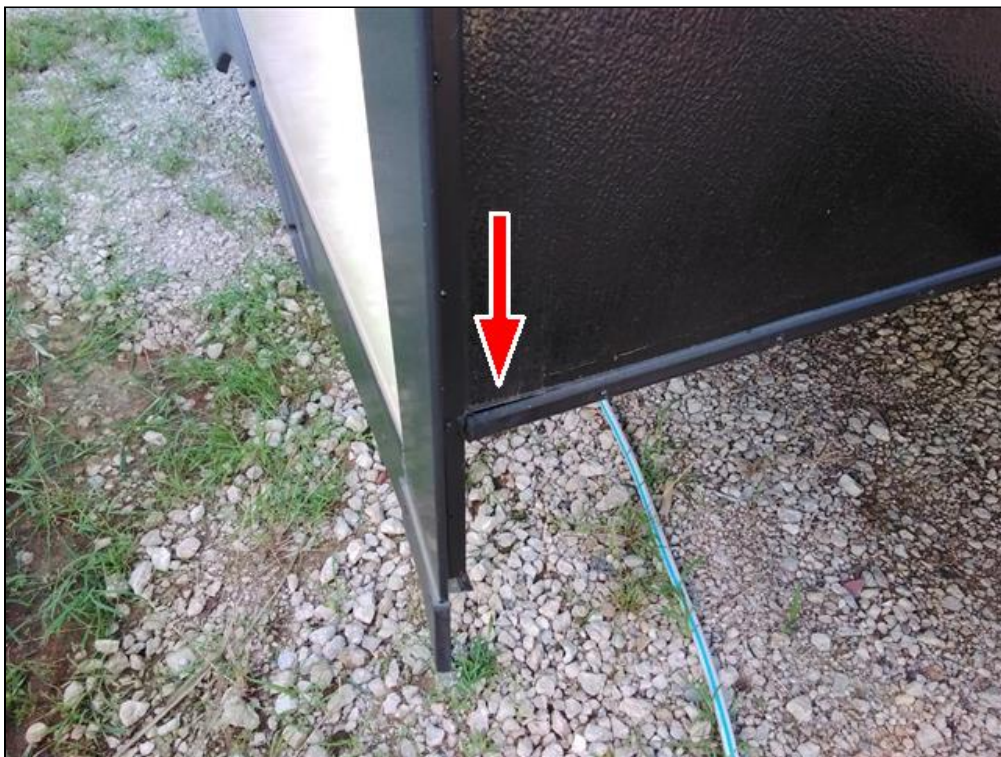
slideout streetside rear trim lower front

(2) The inspector observed on the rear side of the streetside slideout, that the trim is separating from the slideout. It is recommend that this be repaired by a qualified RV technician to avoid future water intrusion.

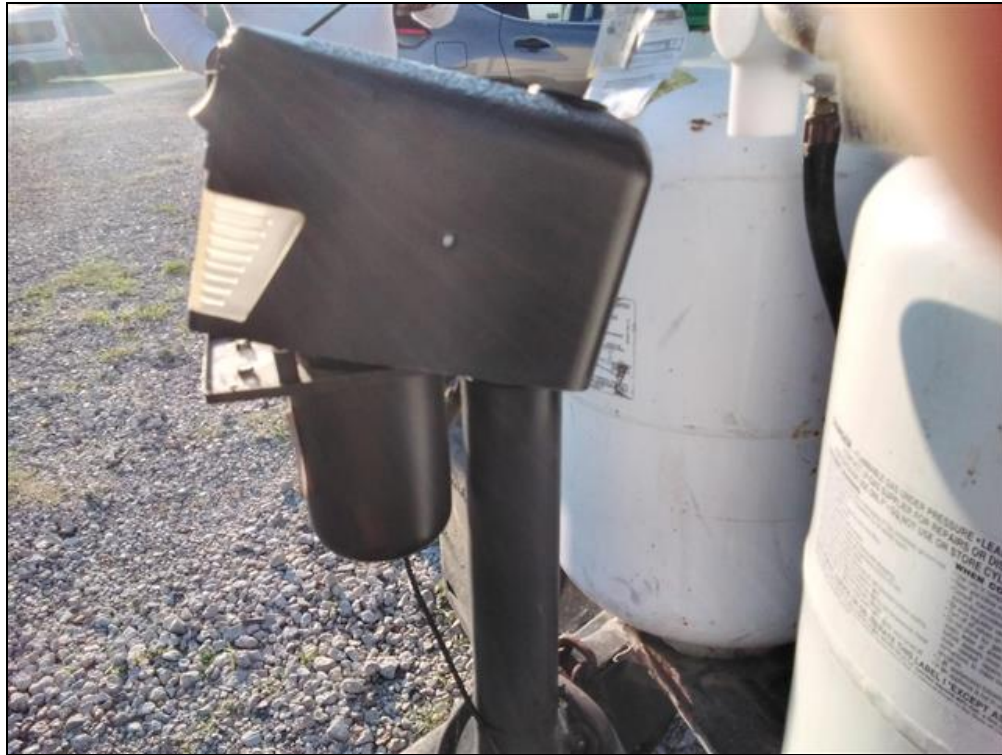
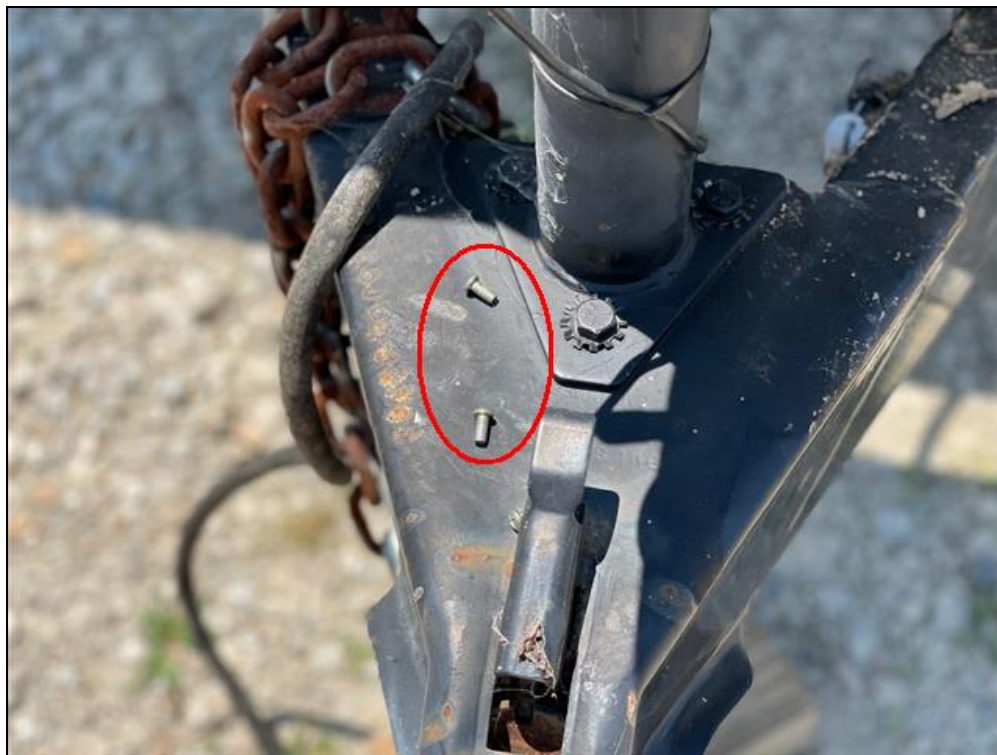
The inspector observed that the travel trailer tongue jack was taken apart. Upon further investigation, it was found that the jack is broken. It is recommend this be repaired by a qualified RV technician.

**+** The inspector observed that the travel trailer tongue jack was taken apart. Upon further investigation, it was found that the jack is broken. It is recommended this be repaired by a qualified RV technician.

Travel Trailer Tongue Jack

Bolts for the Electric Tongue Jack

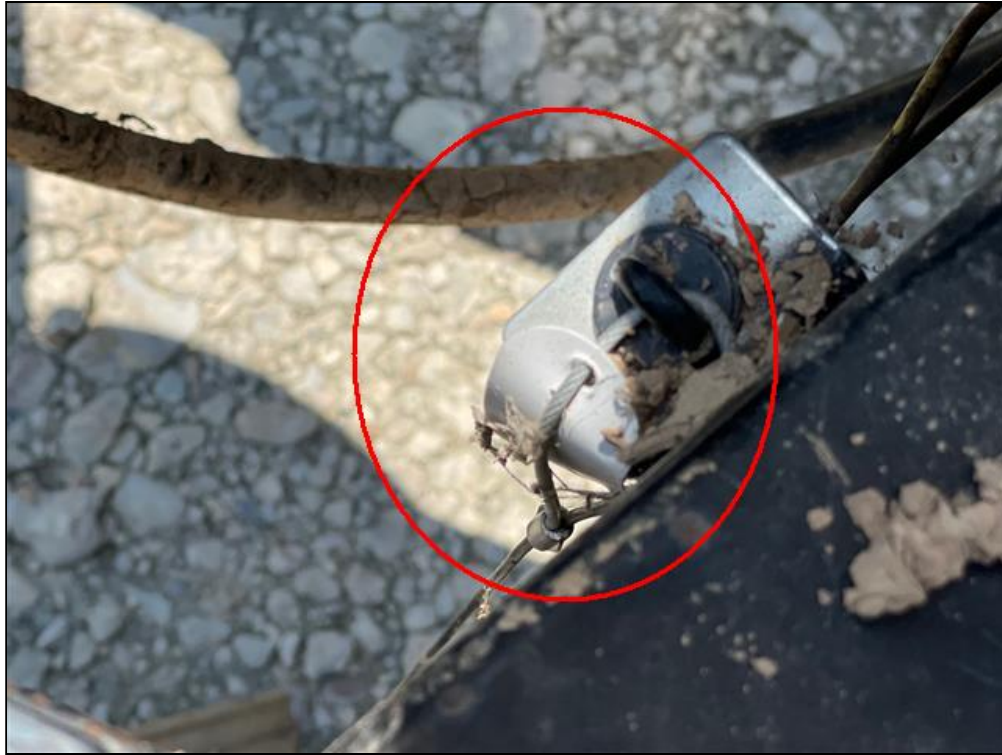
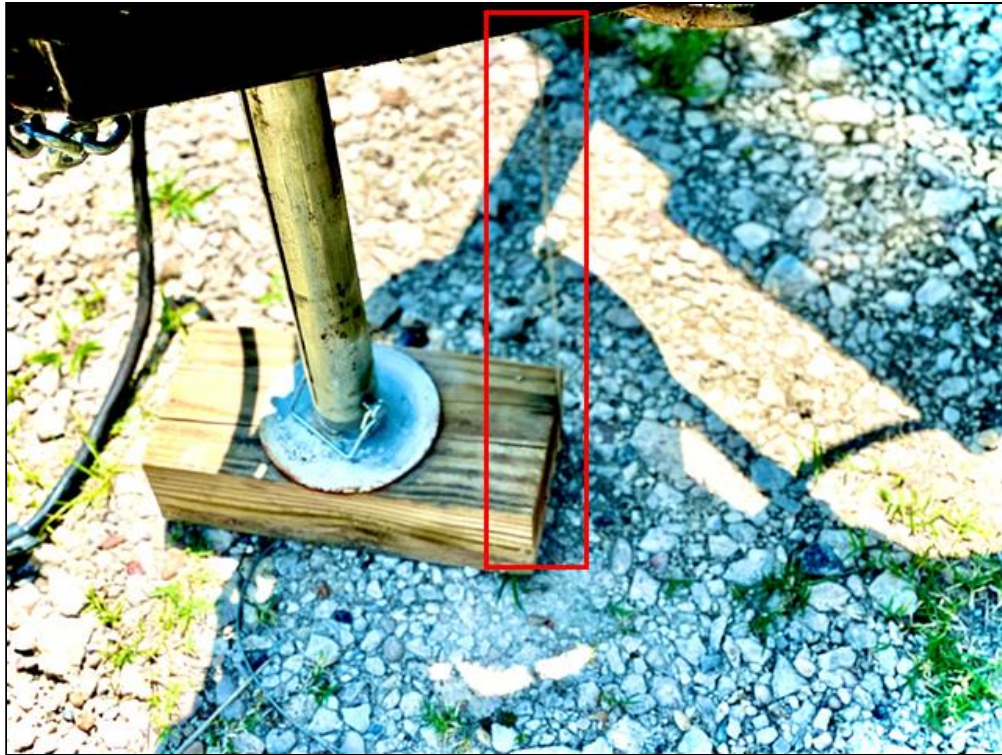
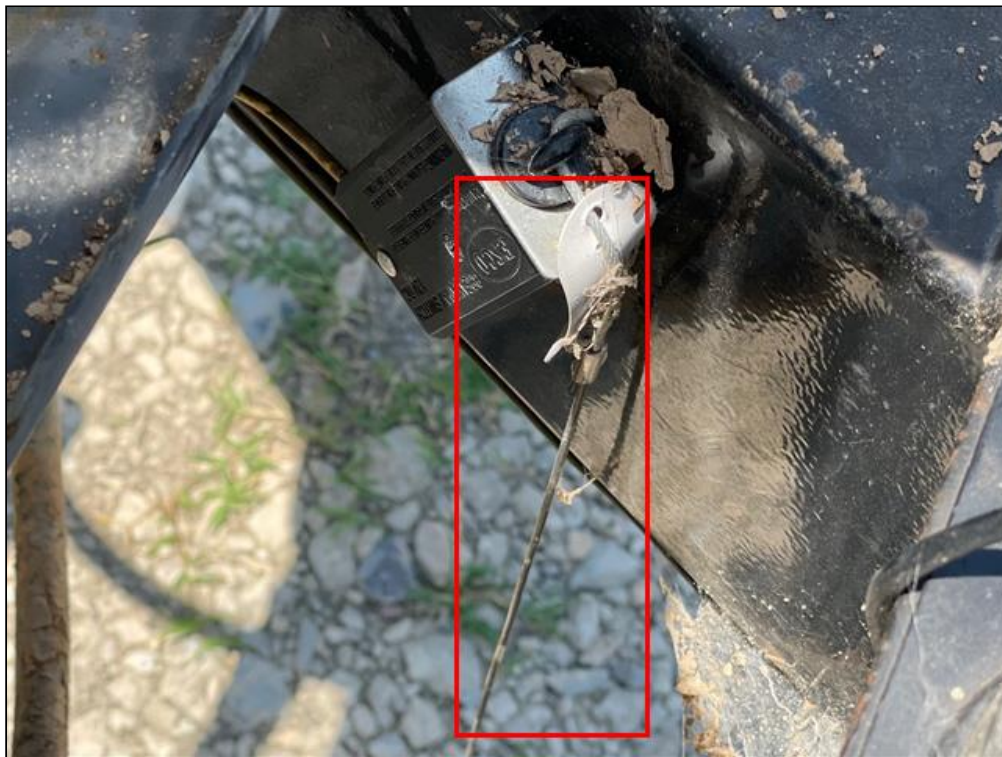
The inspector observed that the breakaway switch cable was stuck under the electric tongue jack pad. This critical safety system could not be tested and cable appears to be under stress. It is recommend this switch be further evaluated by qualified RV technician, since it could not be checked at the time of inspection.

**+** The inspector observed that the breakaway switch cable was stuck under the electric tongue jack pad. This critical safety system could not be tested and cable appears to be under stress. It is recommend this switch be further evaluated by qualified RV technician, since it could not be checked at the time of inspection.

Breakaway Switch 1

Cable stuck under wood block

Cable in stressed position

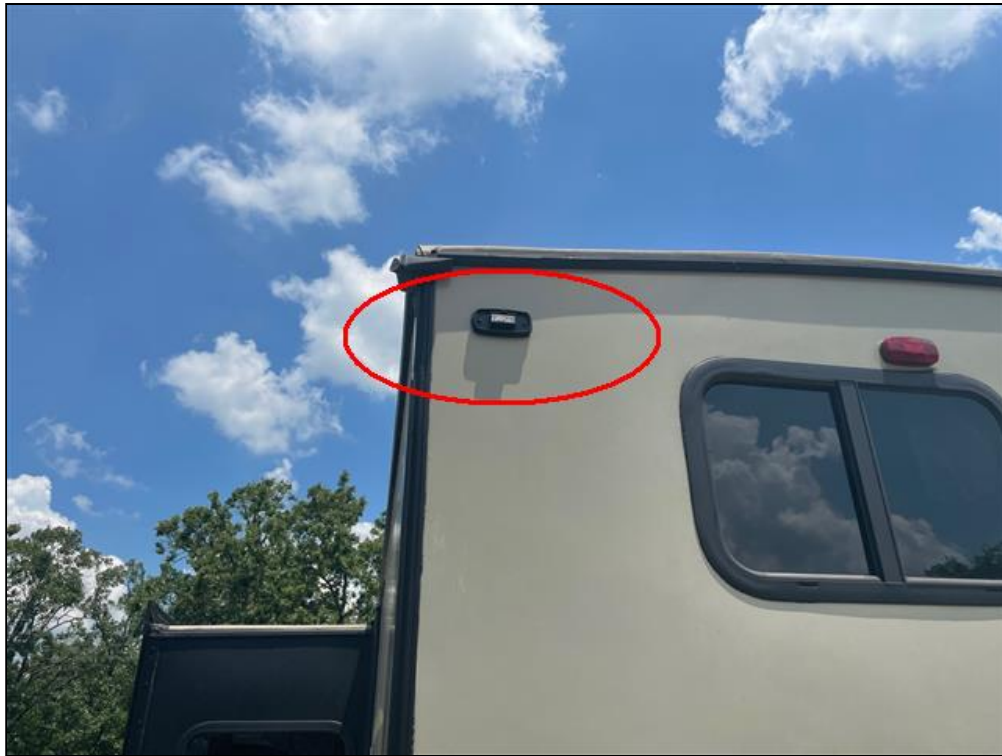
Streetside rear clearance light

The inspector observed that the streetside rear clearance light assembly was functional, but the cover was missing. It is recommend that this be repaired by a qualified RV technician.

**+** The inspector observed that the streetside rear clearance light assembly was functional, but the cover was missing. It is recommend that this be repaired by a qualified RV technician.

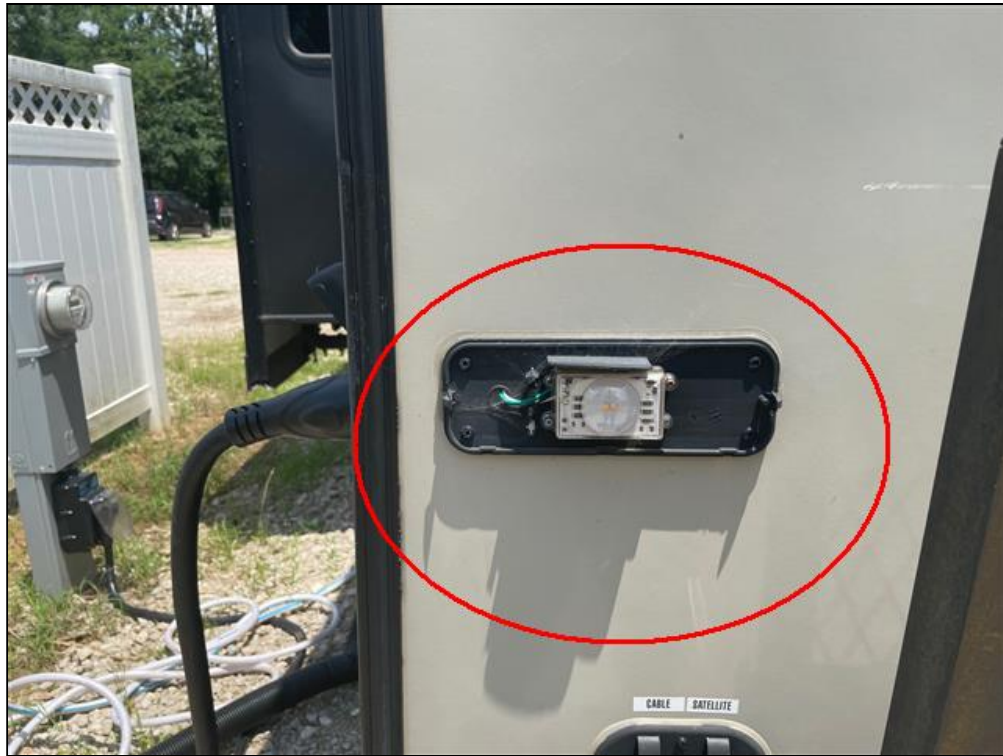
Left Rear Taillight Assembly

The inspector observed that the streetside rear taillight assembly was functional, but the cover was missing. It is recommend that this be repaired by a qualified RV technician.

**+** The inspector observed that the streetside rear taillight assembly was functional, but the cover was missing. It is recommend that this be repaired by a qualified RV technician.

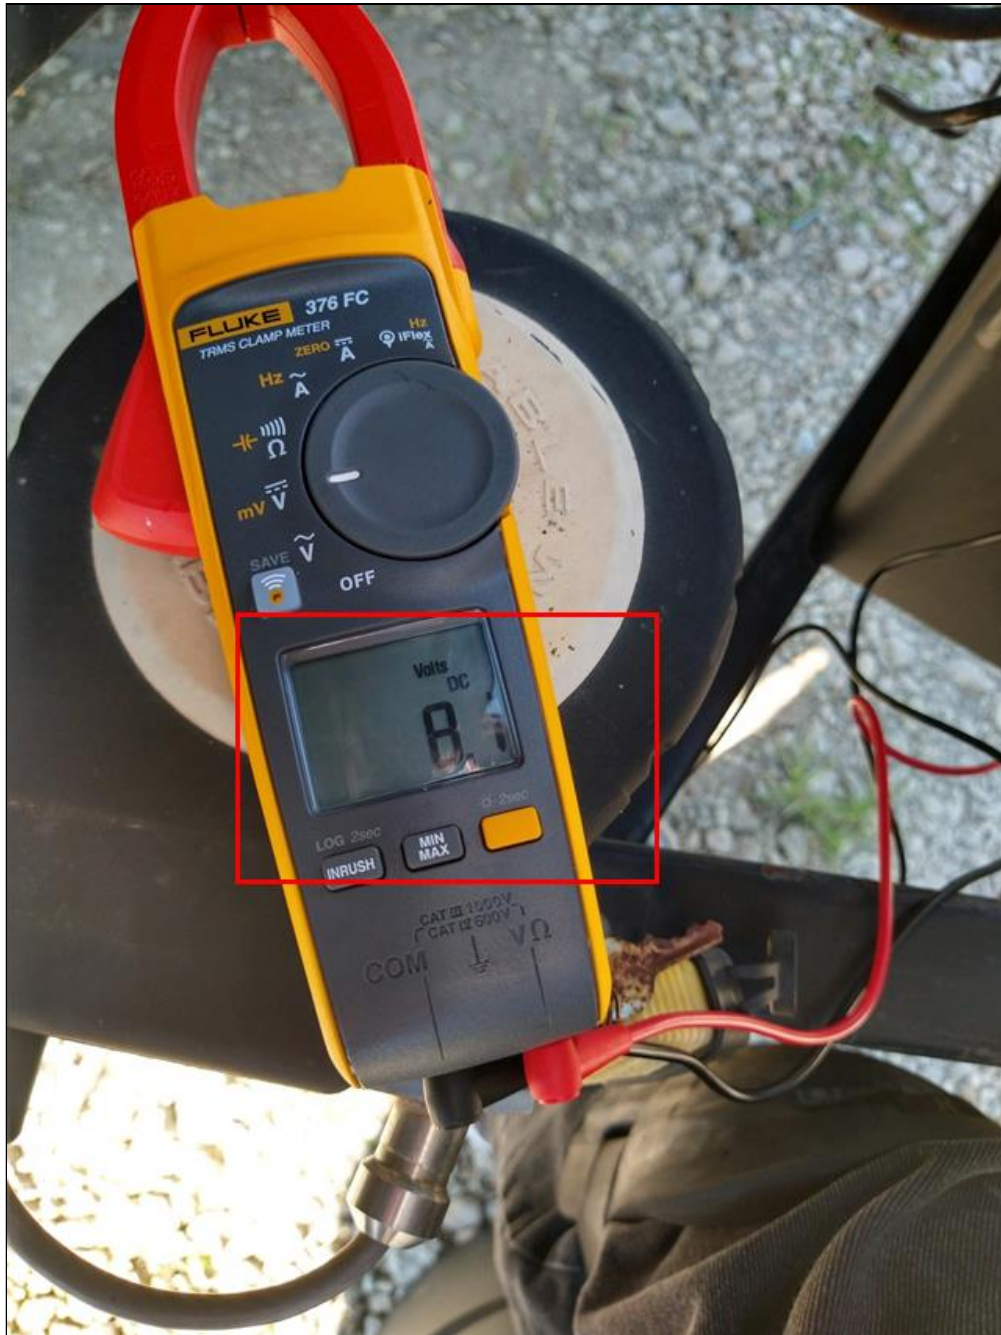
Battery Voltage Test

(1) The inspector observed that battery is only showing 8.1 volts while shore power is plugged in. When unplugging shore power, the voltage did not drop as expected. A battery that will not charge can put added stress on the trailers power converter. It is recommend the battery be repaired by a qualified RV technician or battery specialist.
-

(1) The inspector observed that battery is only showing 8.1 volts while shore power is plugged in. When unplugging shore power, the voltage did not drop as expected. A battery that will not charge can put added stress on the trailers power converter. It is recommend the battery be repaired by a qualified RV technician or battery specialist.

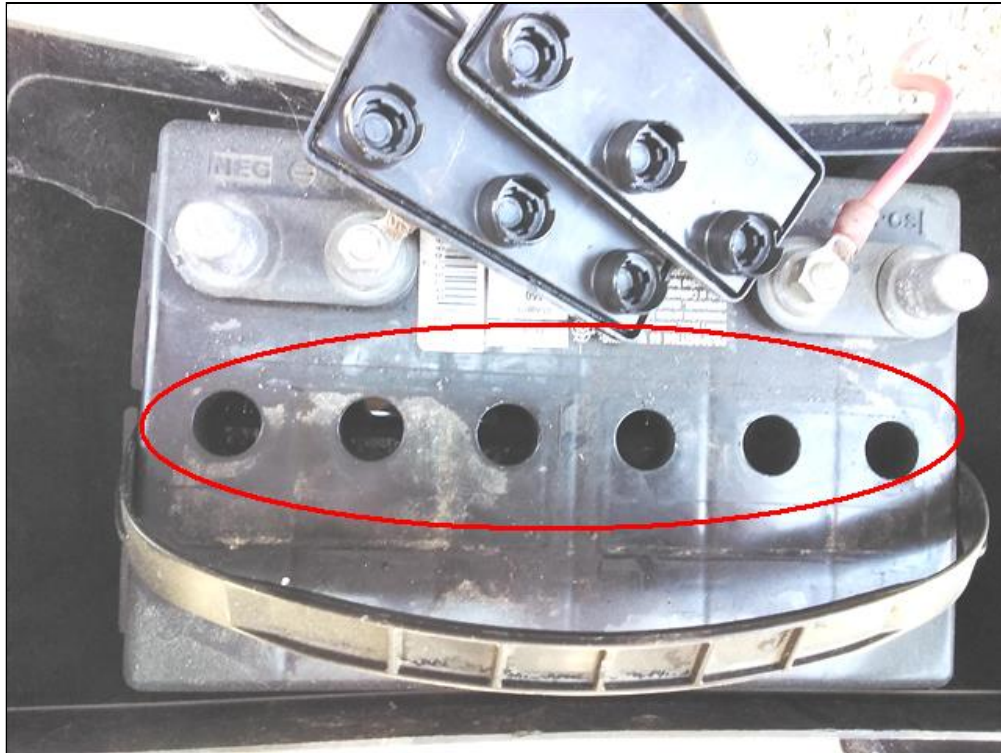
House Battery

(2) The inspector observed that the house battery water level was very low.

**\$** (2) The inspector observed that the house battery water level was very low.

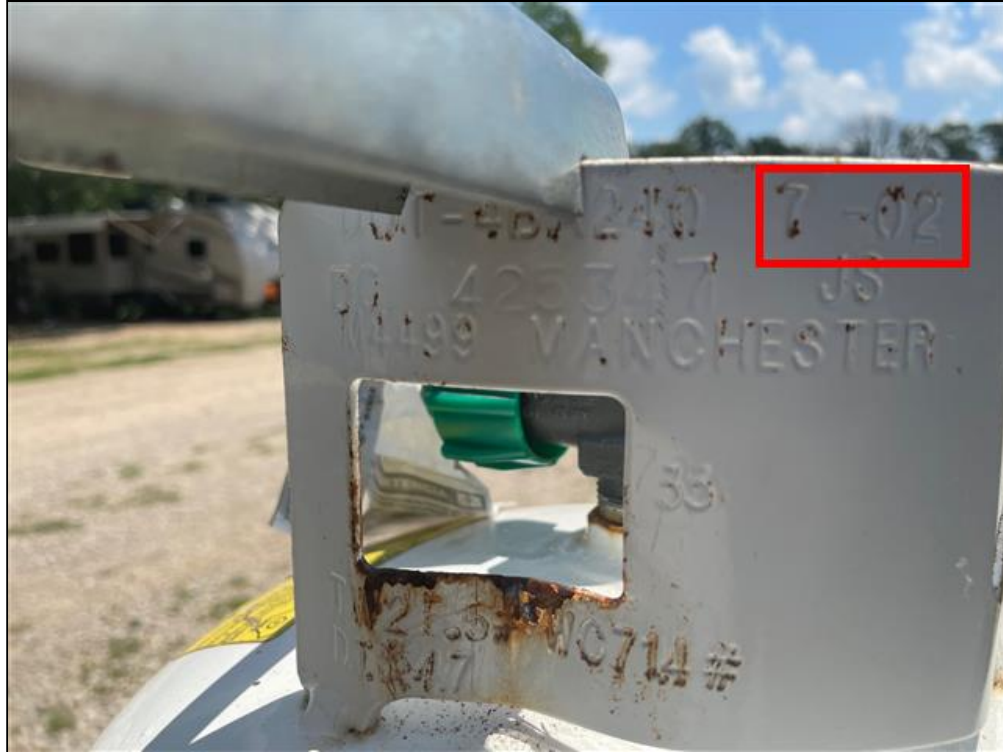
Curbside 30lb LP Tank

(2) The inspector observed that the propane tank is out of date according to the manufacture date on the cylinder collar. It is recommended that the cylinder be re-certified by a qualified propane licensing entity.
-

**+** (2) The inspector observed that the propane tank is out of date according to the manufacture date on the cylinder collar. It is recommended that the cylinder be re-certified by a qualified propane licensing entity.

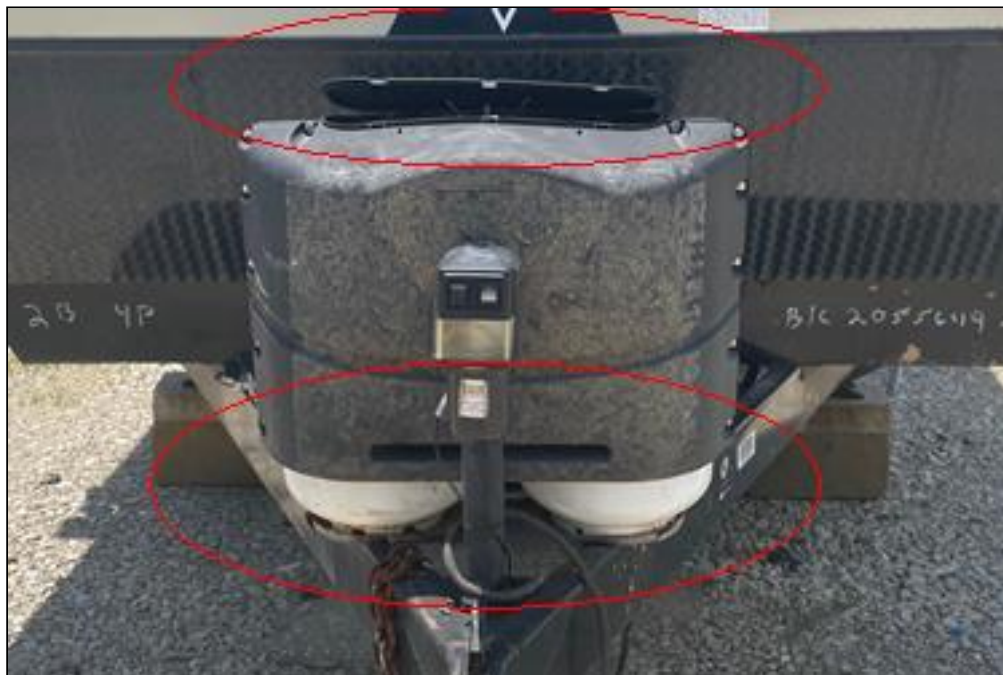
LP COVER FRONT OF TRAILER

(3) The inspector observed that the cover is for 20lb LP cylinders, and 30lb cylinders are installed. The factory brochure specifies that 20lb cylinders are standard. It is recommend this cover or the tanks be repaired by a qualified RV technician.
-

**+** (3) The inspector observed that the cover is for 20lb LP cylinders, and 30lb cylinders are installed. The factory brochure specifies that 20lb cylinders are standard. It is recommend this cover or the tanks be repaired by a qualified RV technician.

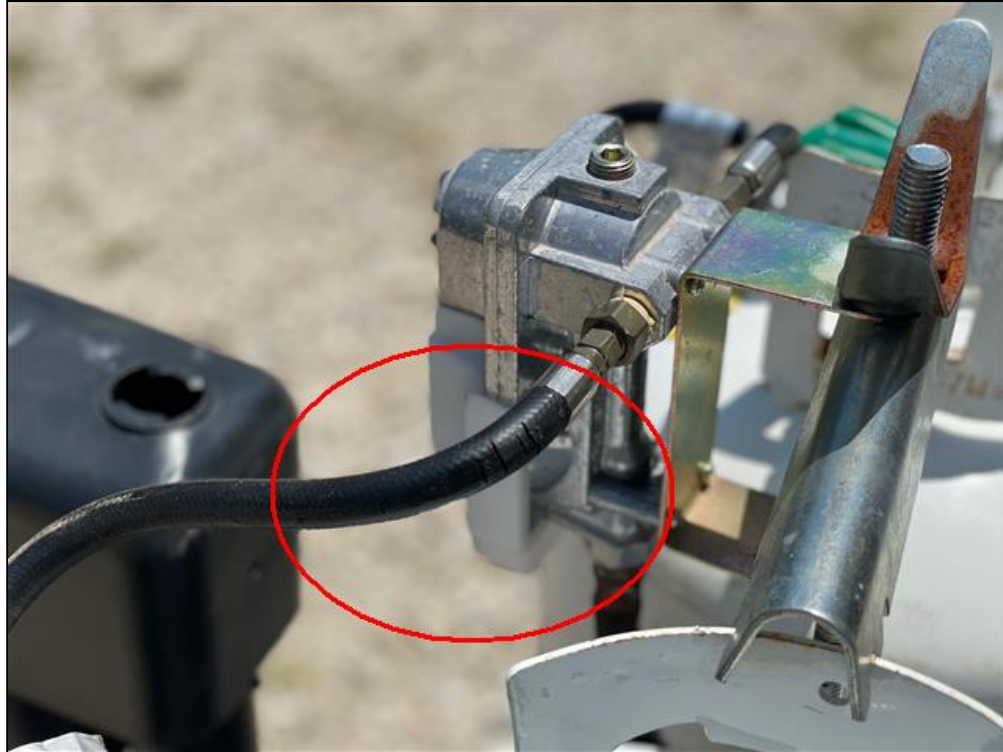
Streetside Propane Supply Hose

(4) The inspector observed that the trailer supply hose coming from the streetside LP cylinder that feeds propane to the trailer has cracks in the hose. This is a life safety issue and the trailer should NOT be occupied until this is repaired by a qualified propane licensed specialist.

**+** (4) The inspector observed that the trailer supply hose coming from the streetside LP cylinder that feeds propane to the trailer has cracks in the hose. This is a life safety issue and the trailer should NOT be occupied until this is repaired by a qualified propane licensed specialist.
