# RV Inspection Report

**Inspection Date:** 6/15/2021

**RV Model: 2018 KZ CONNECT C281BH**

**Mission RV Services**

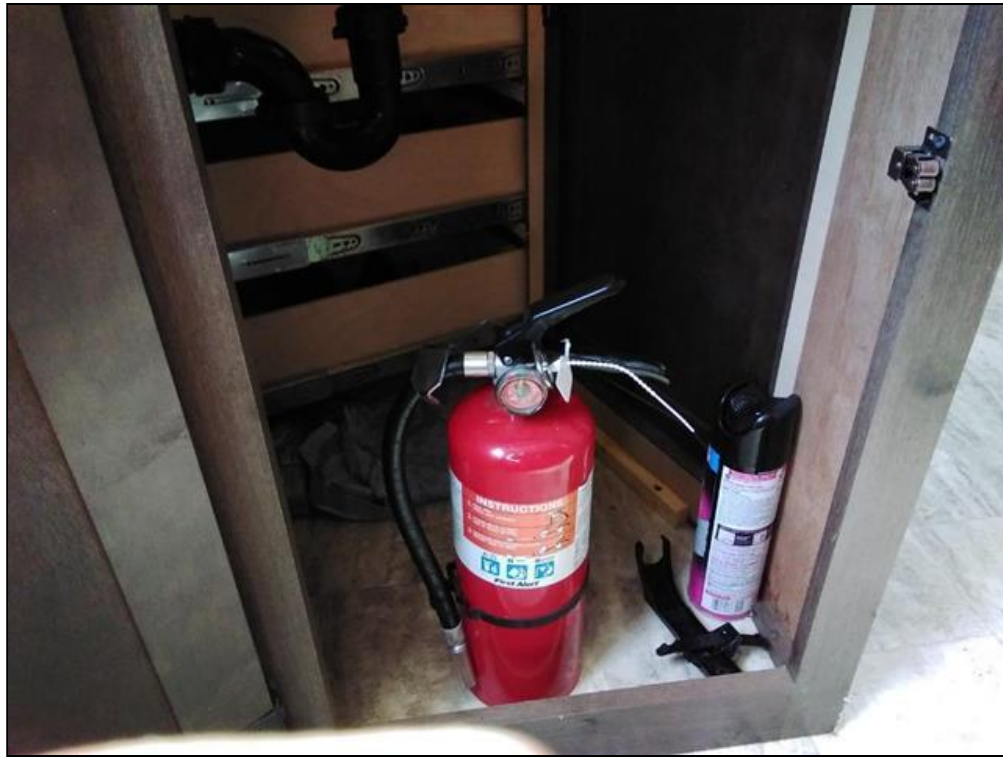
Fire extinguisher loose

The inspector observed that the fire extinguisher was not mounted and is not easily accessible. The fire extinguisher is more than 24 inches away from the entrance door, due to it being inside a cabinet. This is a life safety issue and the trailer should NOT be occupied until this is brought to code. It is recommend that this be repaired by a qualified RV technician.

**+** The inspector observed that the fire extinguisher was not mounted and is not easily accessible. The fire extinguisher is more than 24 inches away from the entrance door, due to it being inside a cabinet. This is a life safety issue and the trailer should NOT be occupied until this is brought to code. It is recommend that this be repaired by a qualified RV technician.

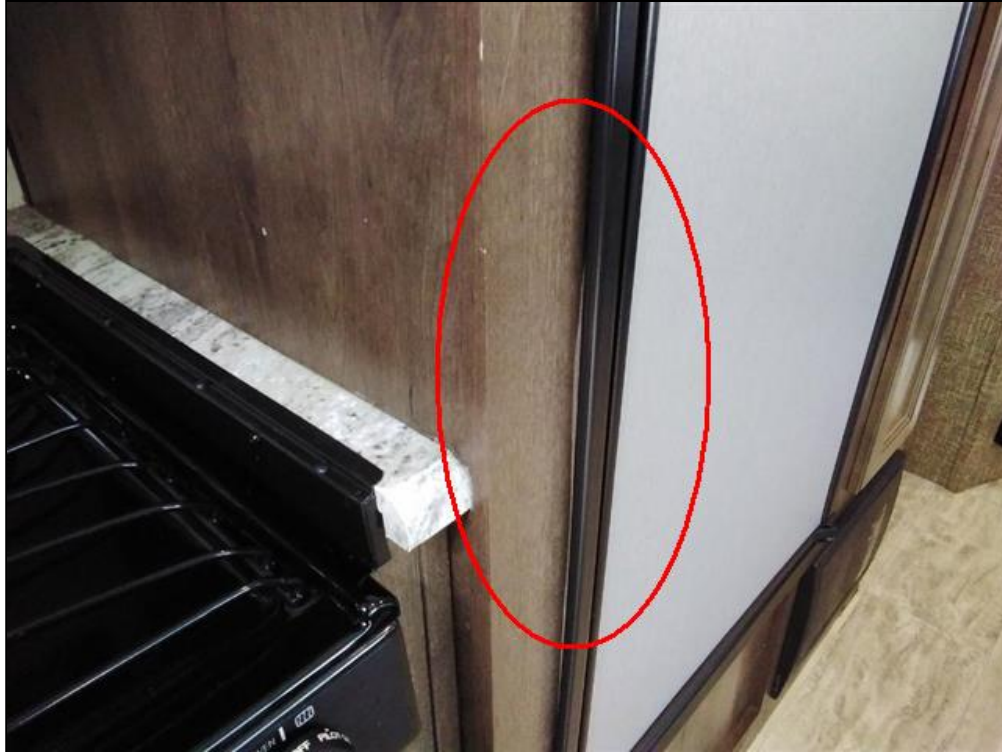
Left lower side refrigerator door frame

The inspector observed that the refrigerator door frame is coming apart on the left side of the door, between the refrigerator door frame and the housing cabinet. It is recommend that this be repaired by a qualified RV technician.

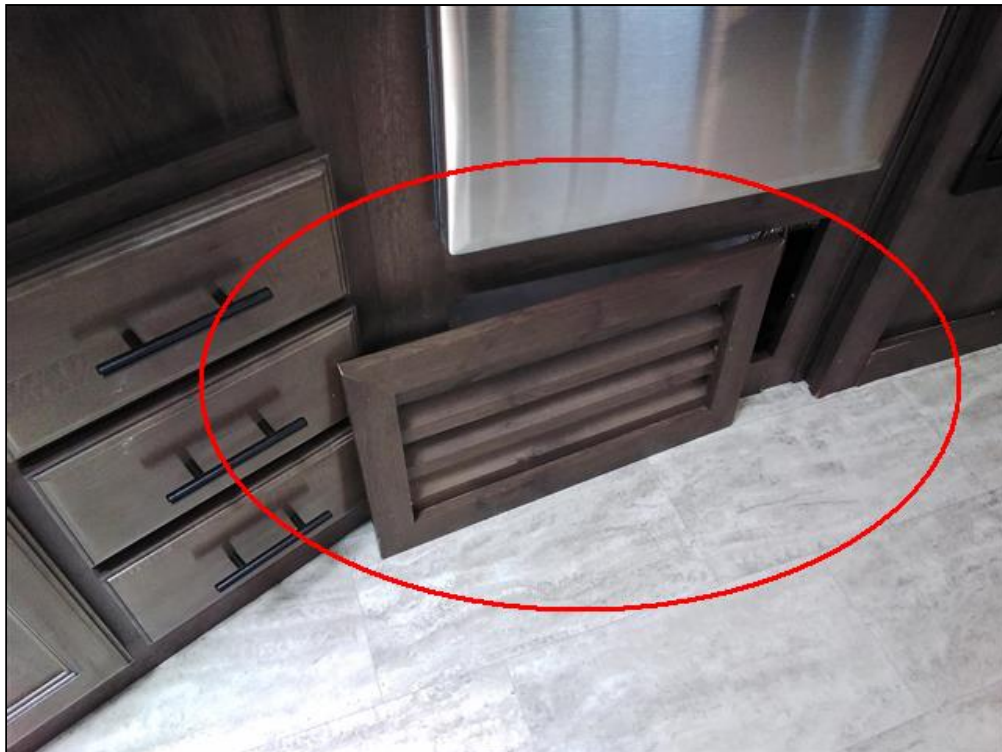
Furnace Air Intake Cover

The inspector observed that the furnace air intake cover was damaged and missing screws. It is recommended that this be repaired by a qualified RV technician.

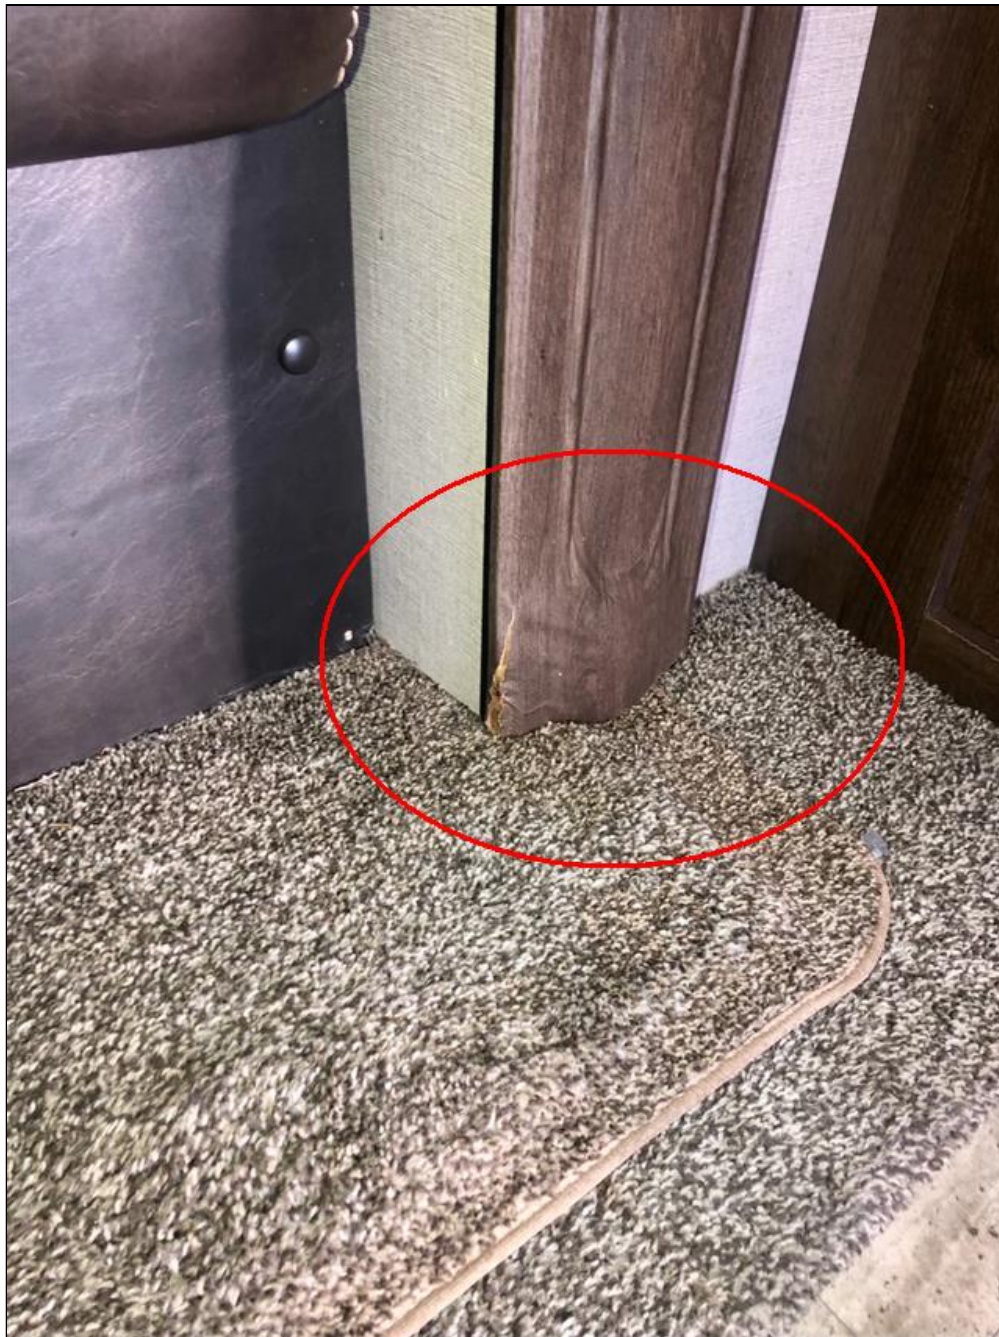
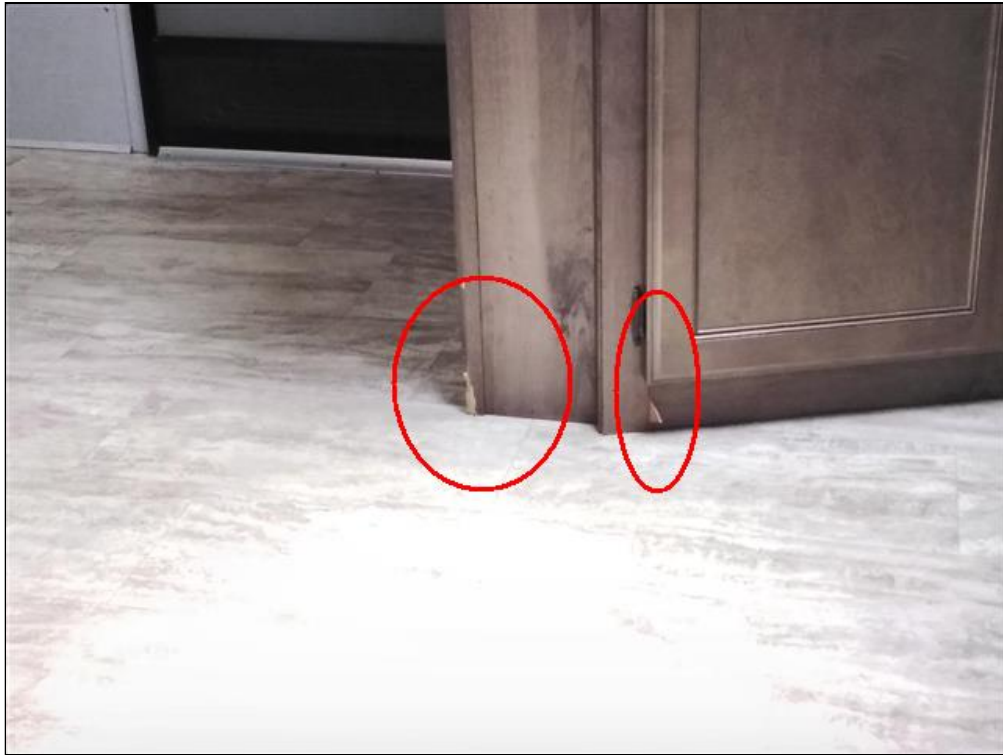
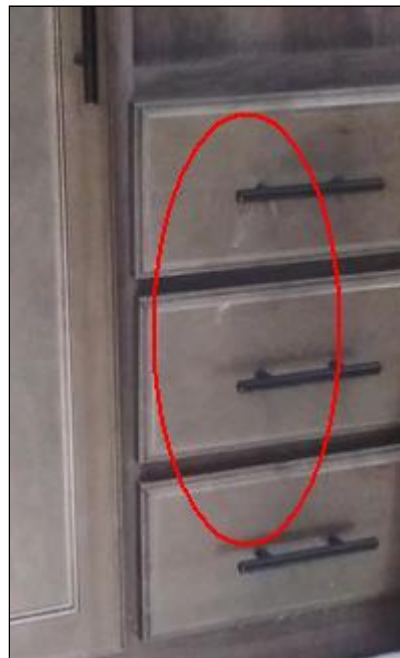
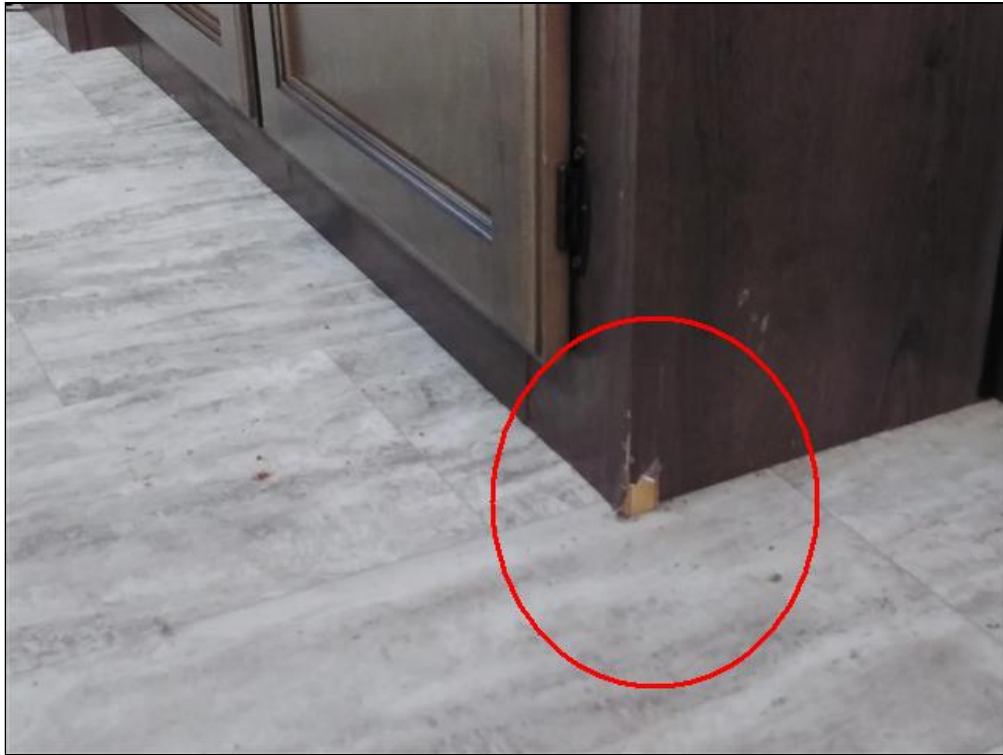
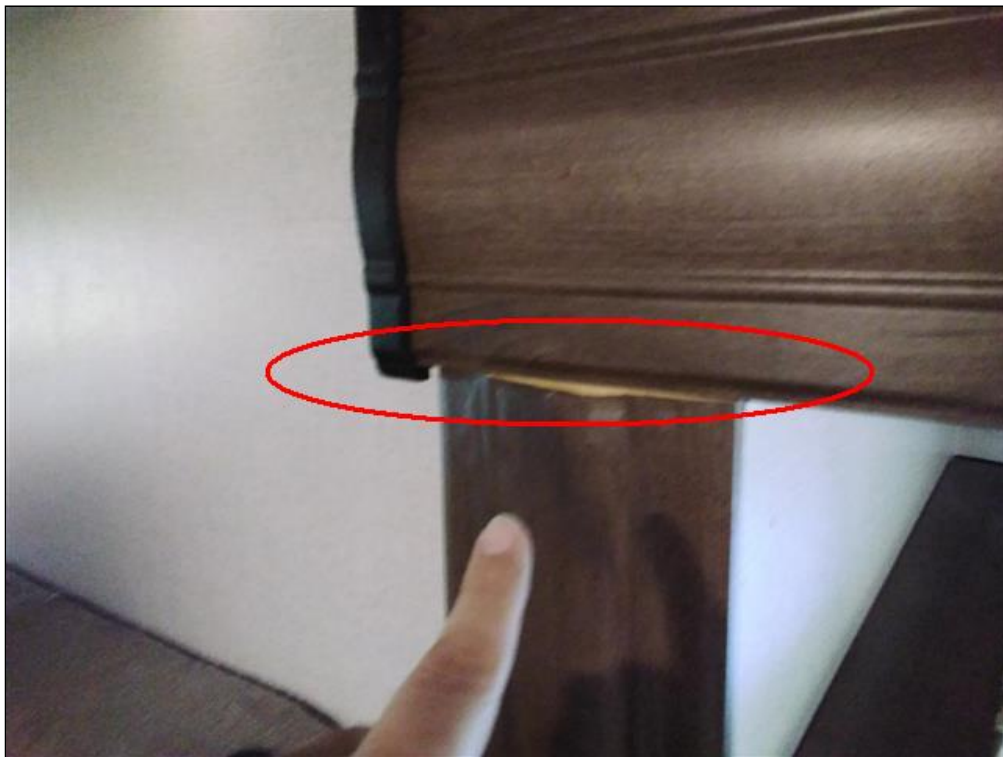
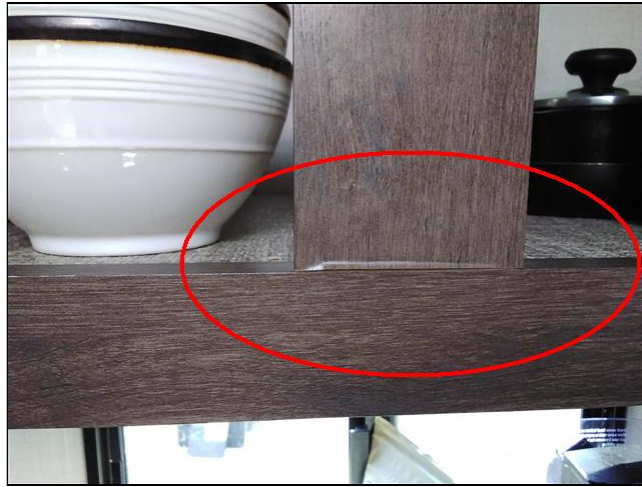
The inspector observed examples of various scuffs and scratches in and around the trailer that are minor moderate, including broken trim work on the slideout and a broken furnace cover. It is recommend these be repaired by a qualified RV technician.

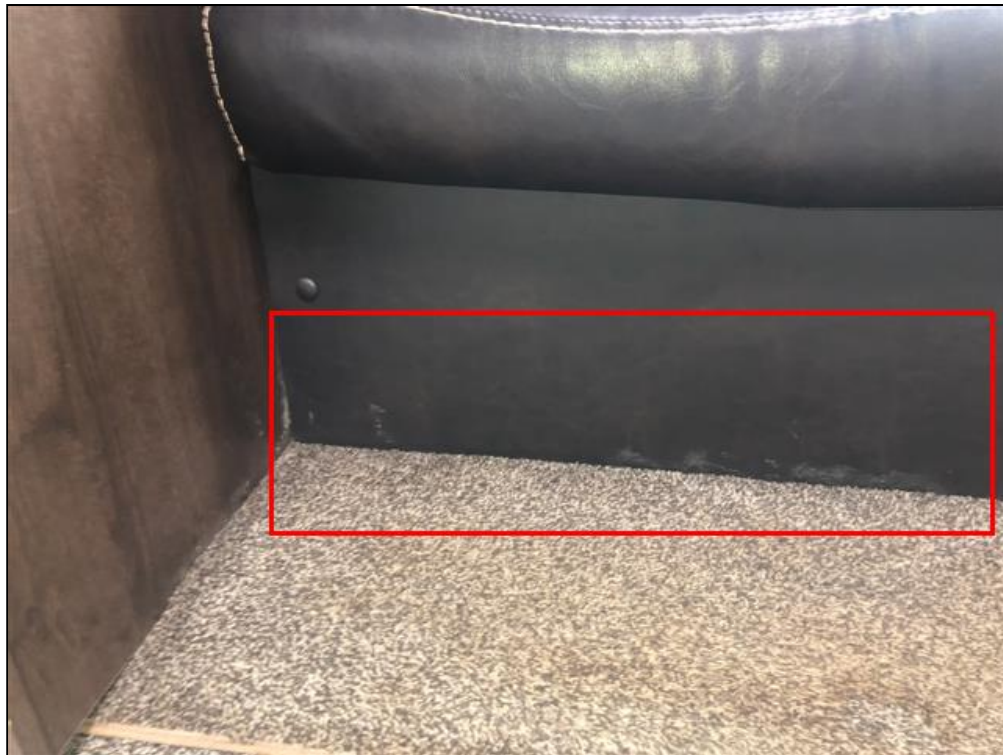
Bottom left side of sofa

(1) The inspector observed scuffs and scratches bottom left side of sofa.

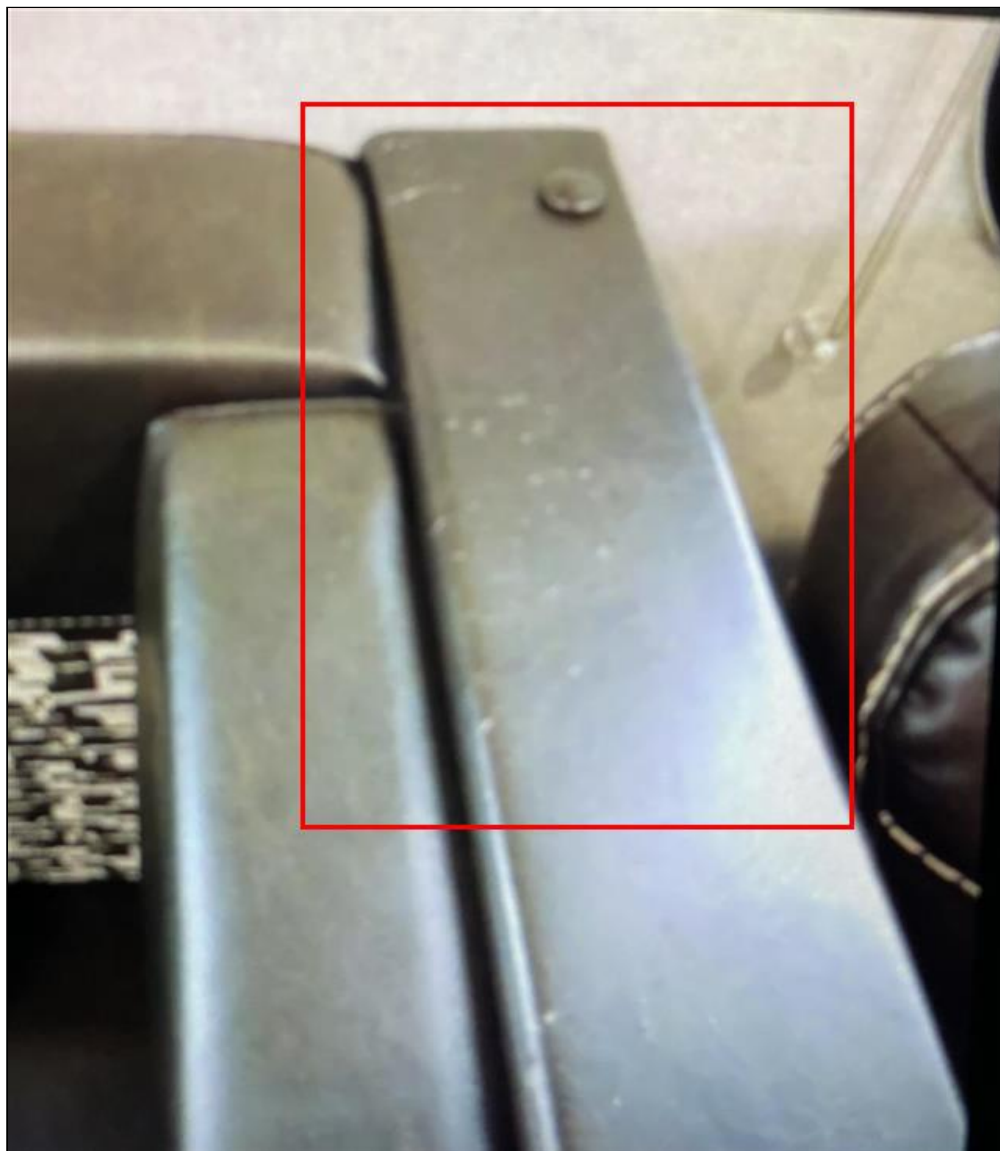
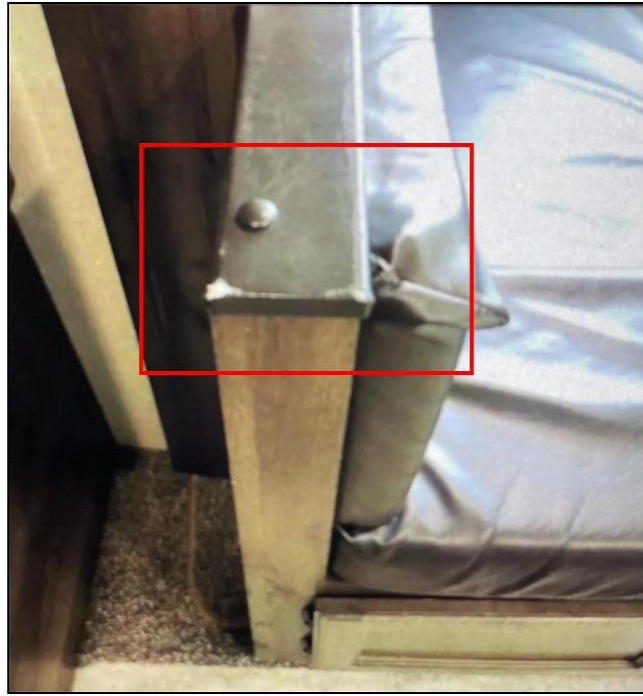
The inspector observed signs of wear on the right and left side top of the kitchen dinette, which could be from a pet.

Minor Damage Right side Dinette

Left side arm kitchen dinette

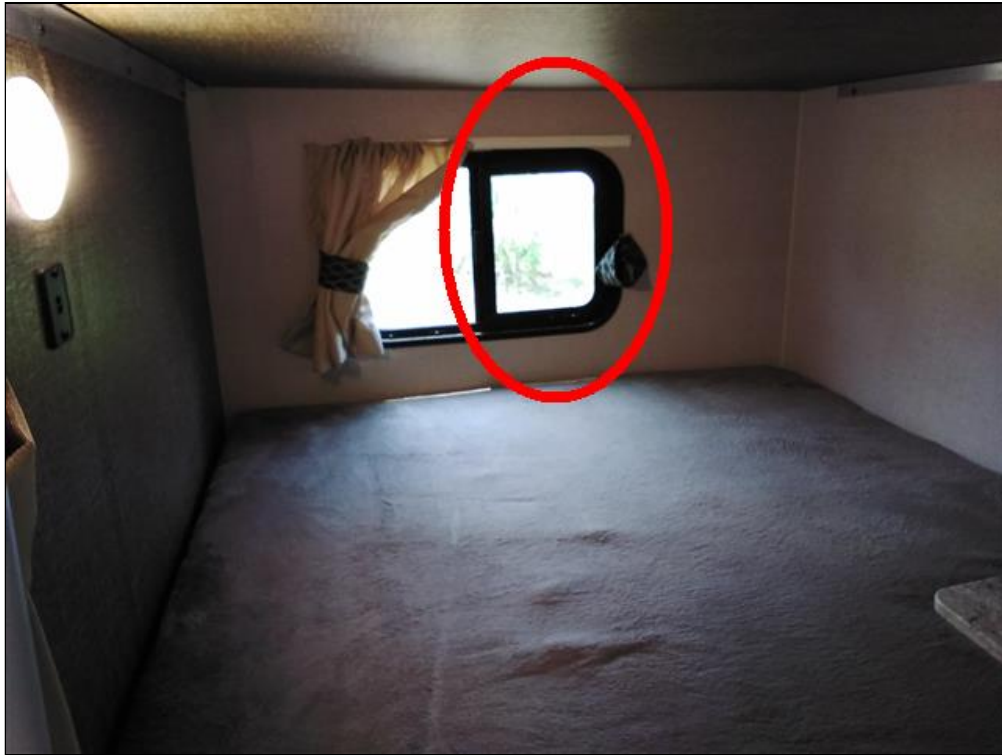
Lower Bunk Window

The inspector observed that the right side curtain on the lower bunk bed is missing.
